June 17, 2021

# 2021 Planning Advisory Group Meeting

# Northern Maine Transmission System

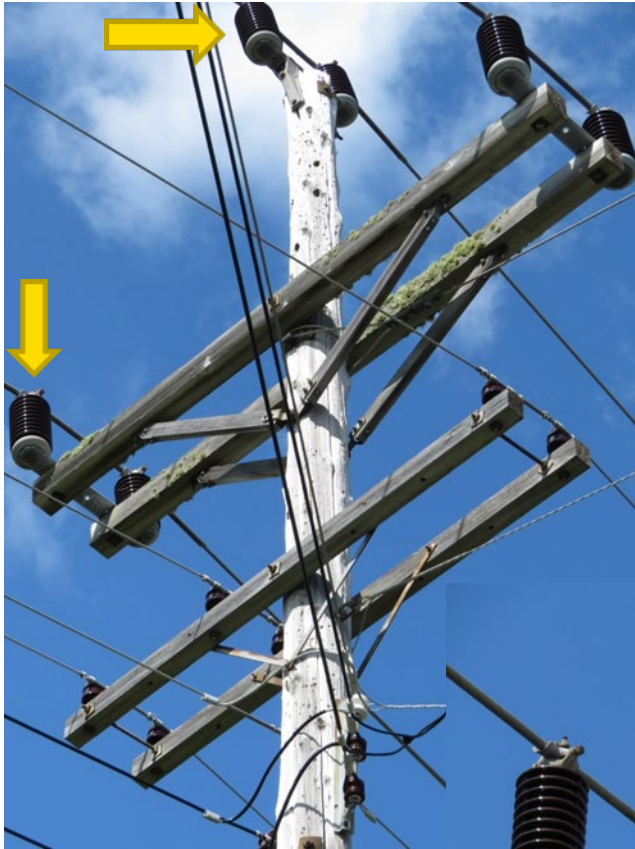
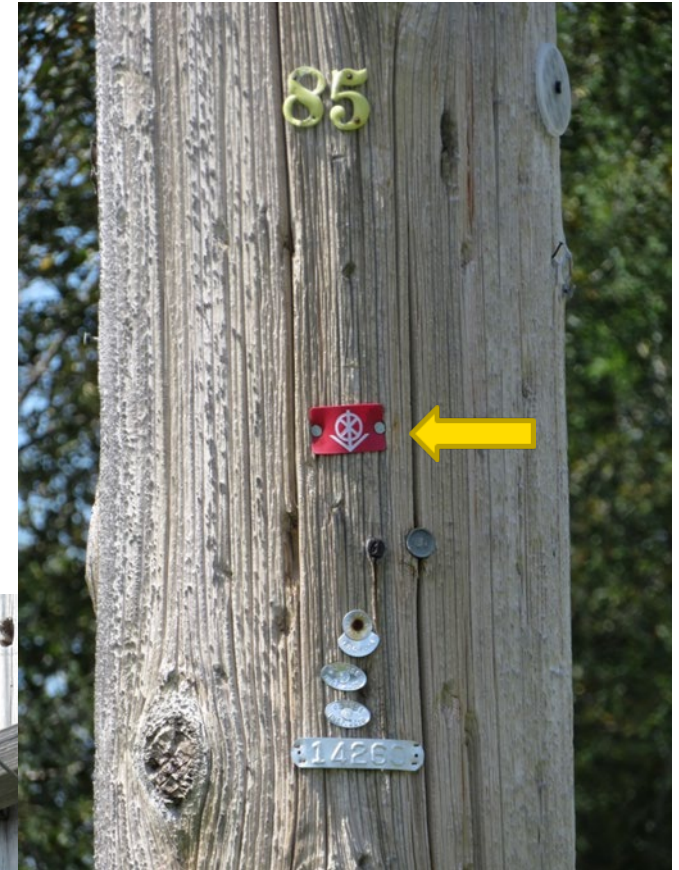
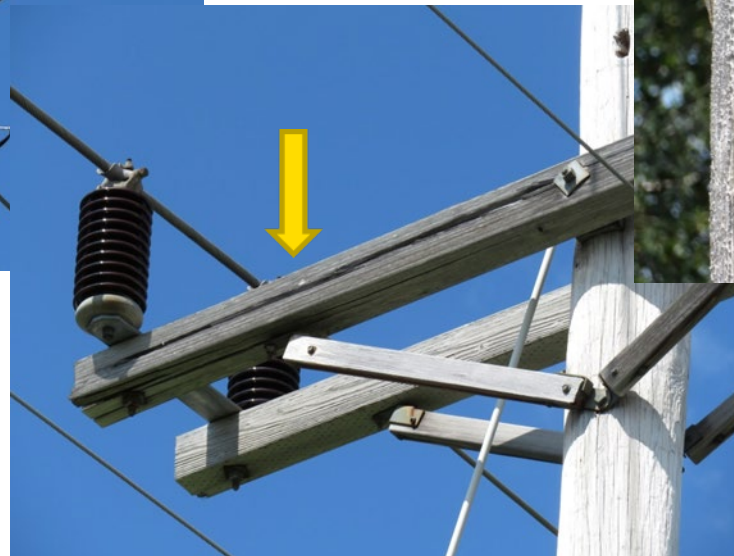
# Line 6903 Rebuild (Caribou & Limestone)

**Brown glass post type insulators, cracked crossarms and rejected pole due to internal decay**

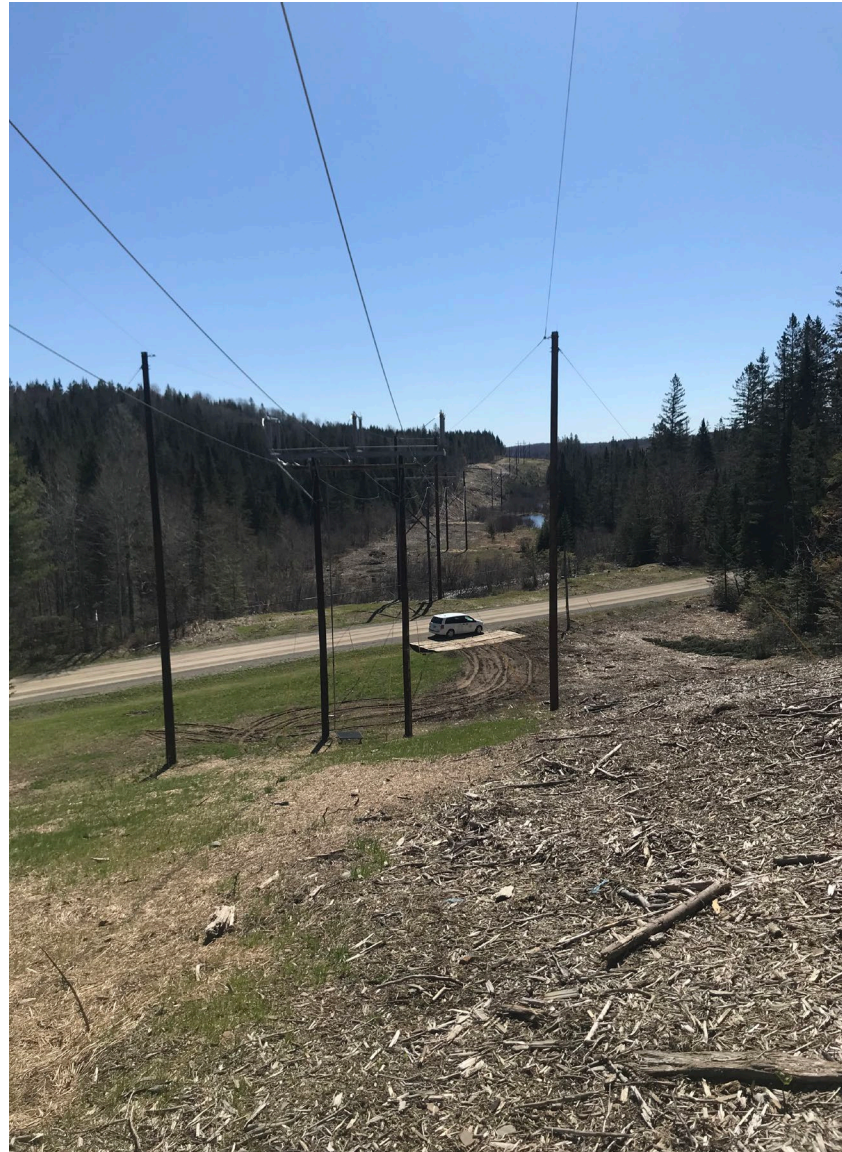
Lack of H-frame  
"K" bracing leads  
to structure  
instability

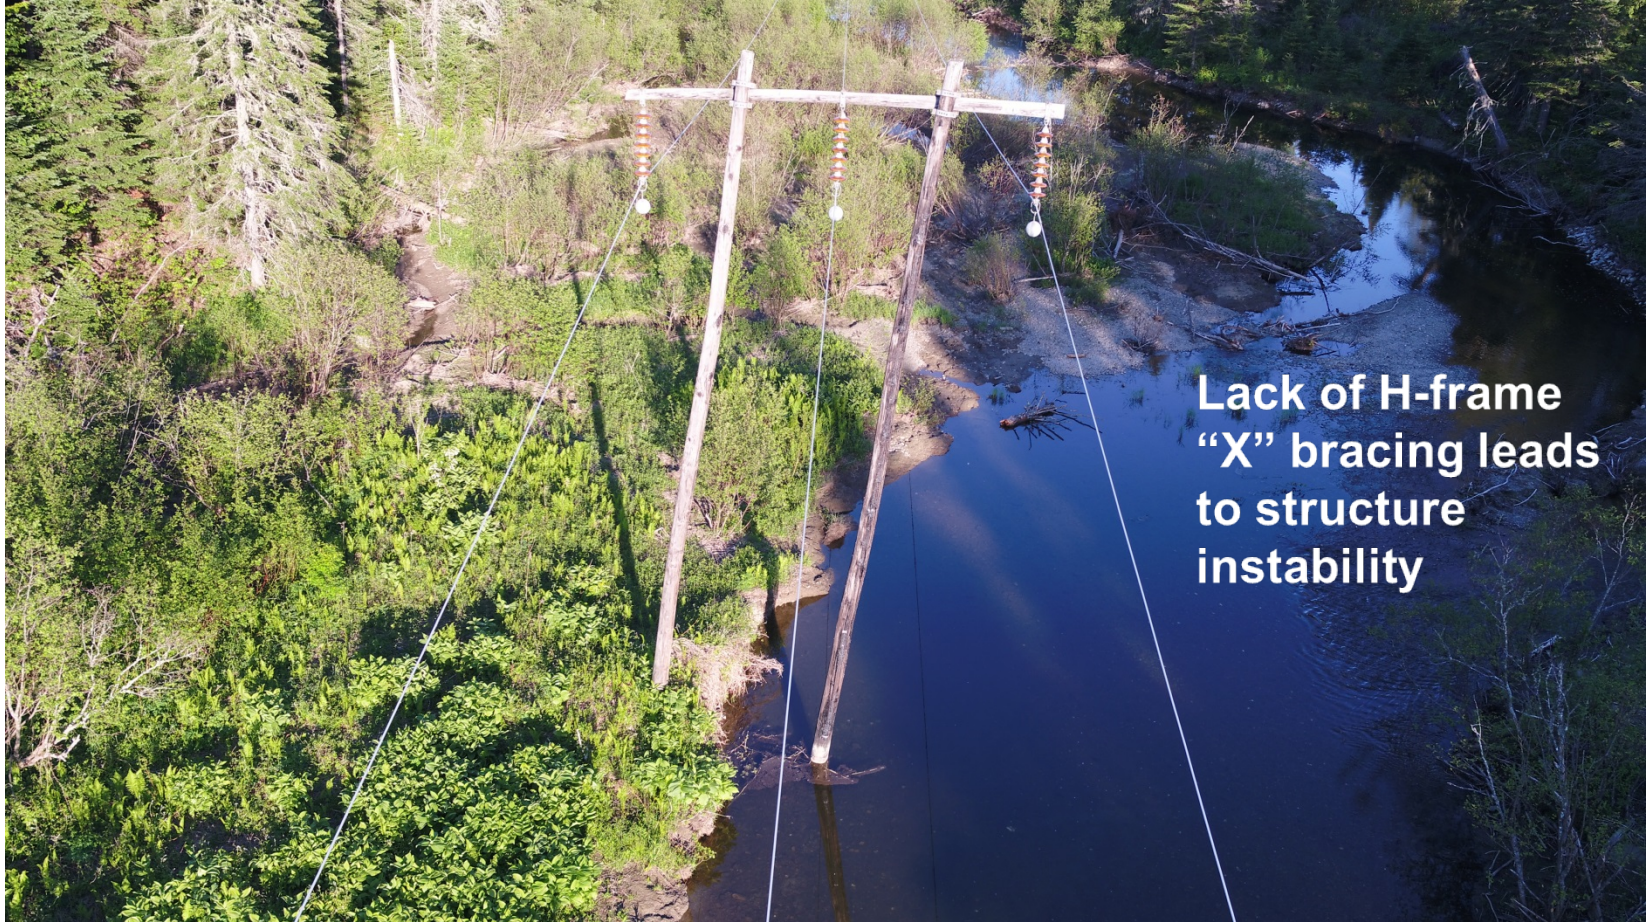
Lack of H-frame  
“X” bracing leads  
to structure  
instability

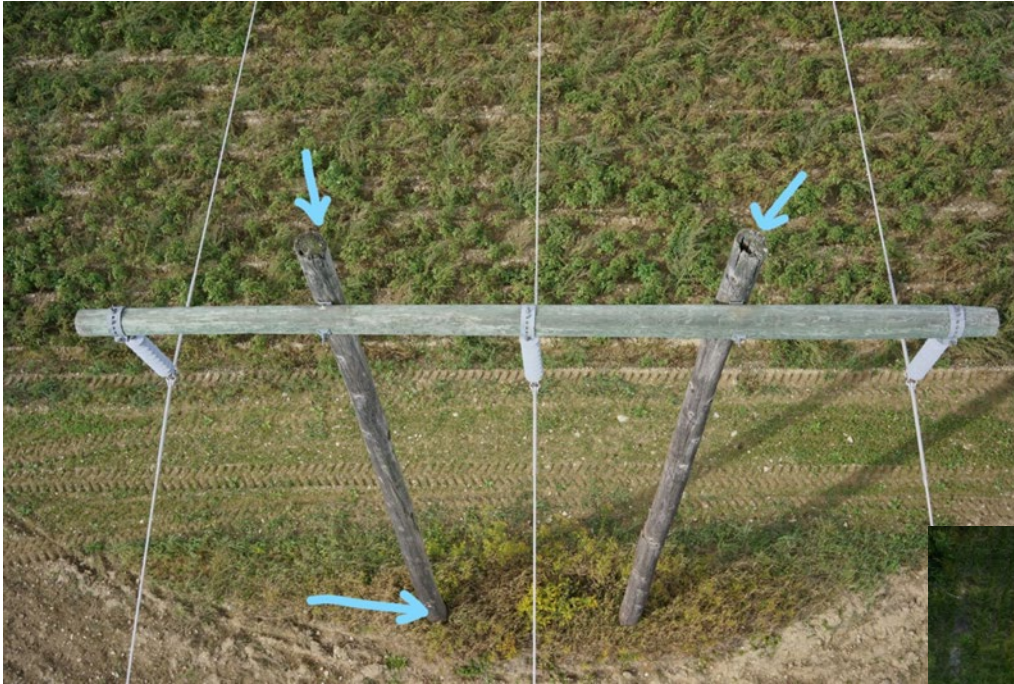
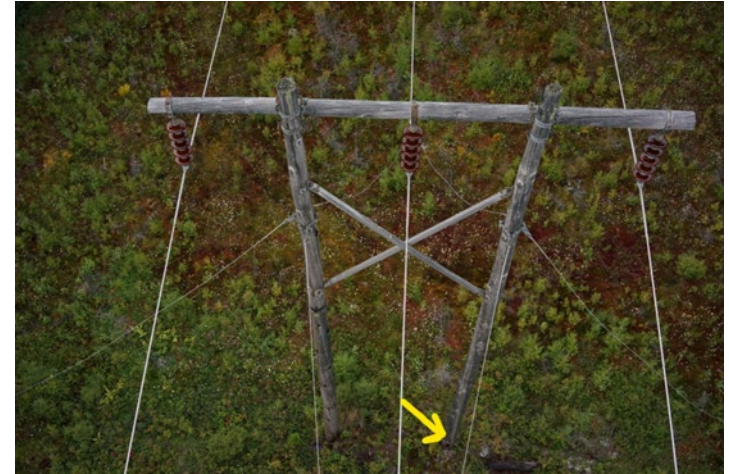
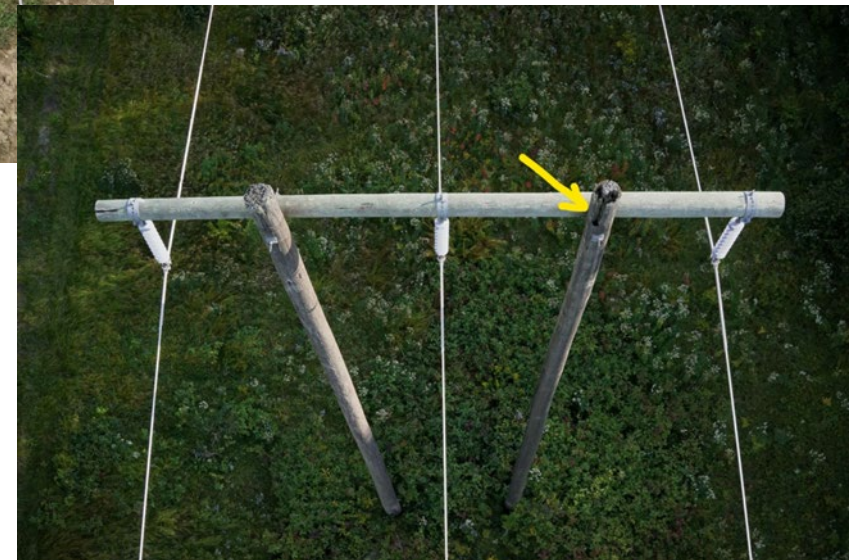
# Line 6905 Emergency Pole Replacements

**Excessive pole and crossarm rot detected by UAS (a.k.a. drone) inspection resulted in an emergency structure replacement project**

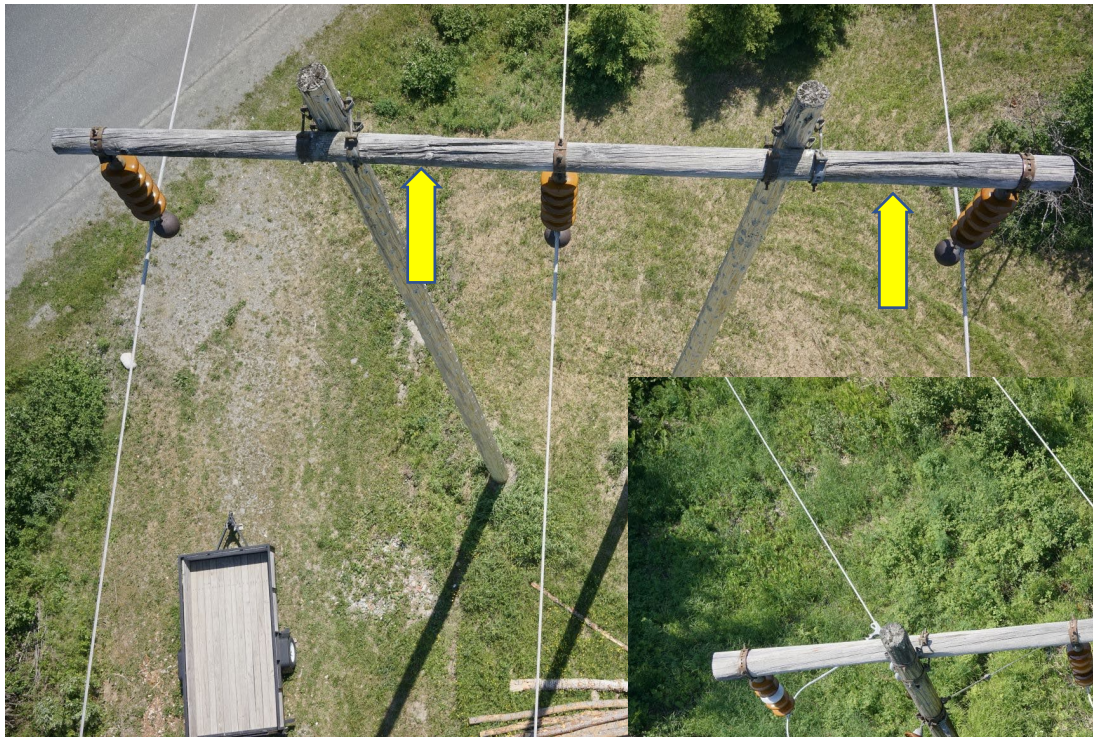
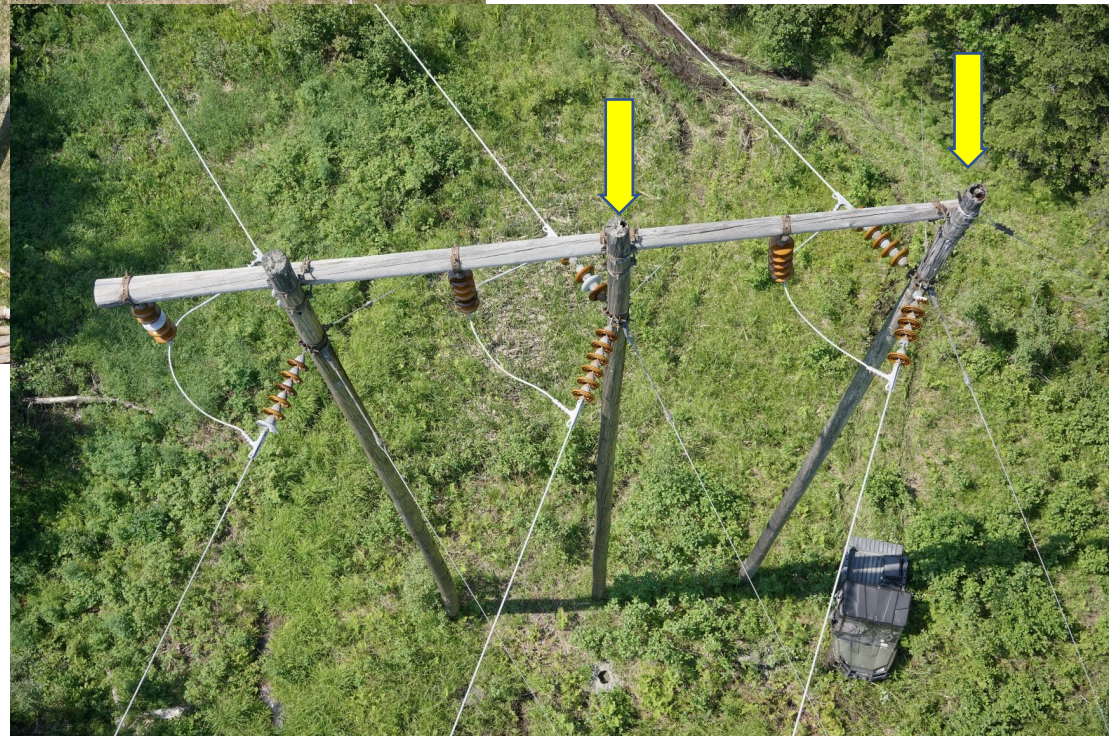
Line 6909 built in 1961, comprised of 160 wood pole structures.

13% rejected in 2019 due to insufficient shell thickness, this quantity will continue to climb as this line ages

Rotting wood pole crossarms and pole tops

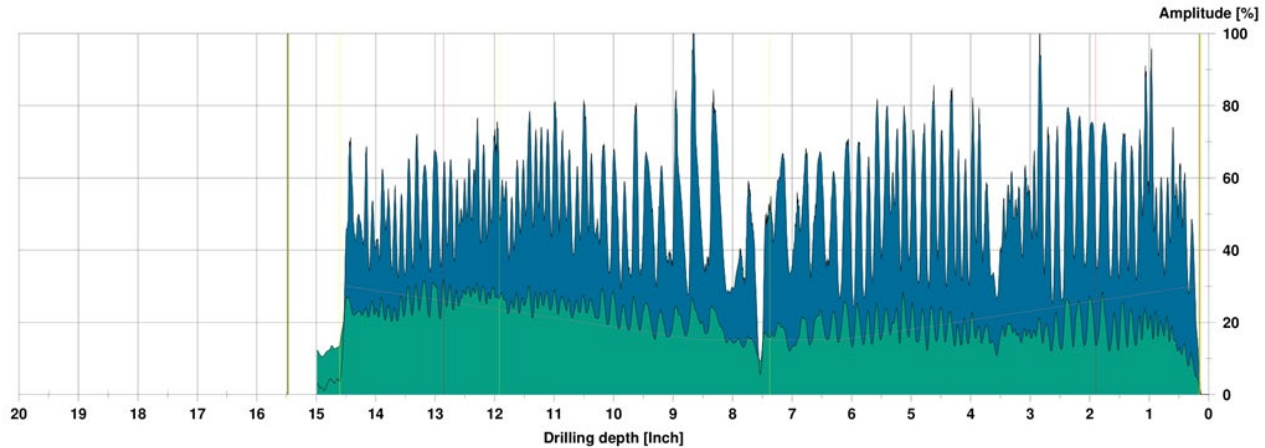
20694M047 (PASS).rgp

# Resistograph Plot - Wood Pole in good condition

Program	: Pole - EMERA 1.00	Sum decay	: 0,0%   0,0%   0,0%
Pole type	:	Heart rot	: 0,0%   0,0%   0,0%
Measurement	: Below soil level	Shell rot	: No   No
Defect pattern	: No decay	Remaining wall	: 50,0%   50,0%   50,0%
Result (auto)	: PASS	Strength	: 100,0%   100,0%   100,0%

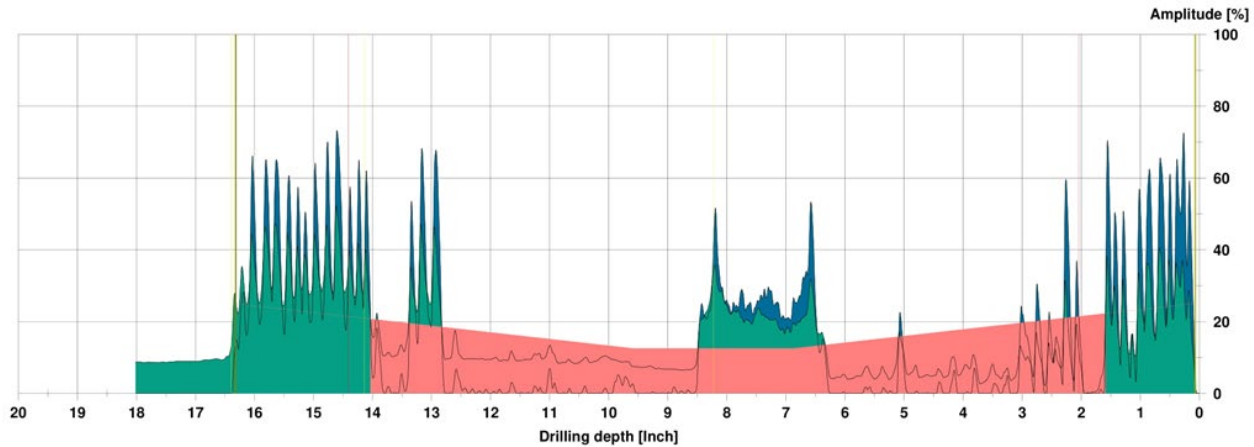
20781M013 (REJECT).rgp

# Rejected Wood Pole – Heart Rot

Program :	Pole - EMERA 1.00	Sum decay :	40,7%	35,6%	76,3%
Pole type :		Heart rot :	40,7%	35,6%	76,3%
Measurement :	Auto diameter	Shell rot :	No	No	
Defect pattern:	Heart rot	Remaining wall:	9,3%	14,4%	11,8%
Result (auto) :	REJECT	Strength :	56,1%	74,3%	65,2%

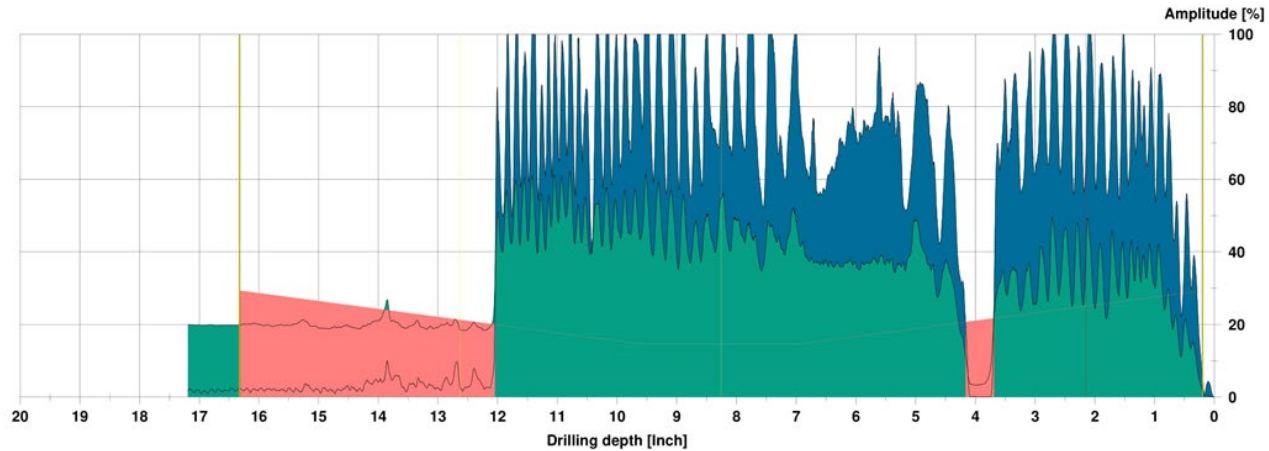
20705M046 (REJECT).rgp

# Rejected Wood Pole – Heart Rot & Shell Rot

Program :	Pole - EMERA 1.00	Sum decay :	2,9%	0,0%	2,9%
Pole type :		Heart rot :	2,9%	0,0%	2,9%
Measurement :	Below soil level	Shell rot :	No	Yes	
Defect pattern:	Heart+shell rot	Remaining wall:	21,7%	---	
Result (auto) :	REJECT	Strength :	89,7%	---
