June 17, 2021

# 2021 Planning Advisory Group Meeting

# Northern Maine Transmission System

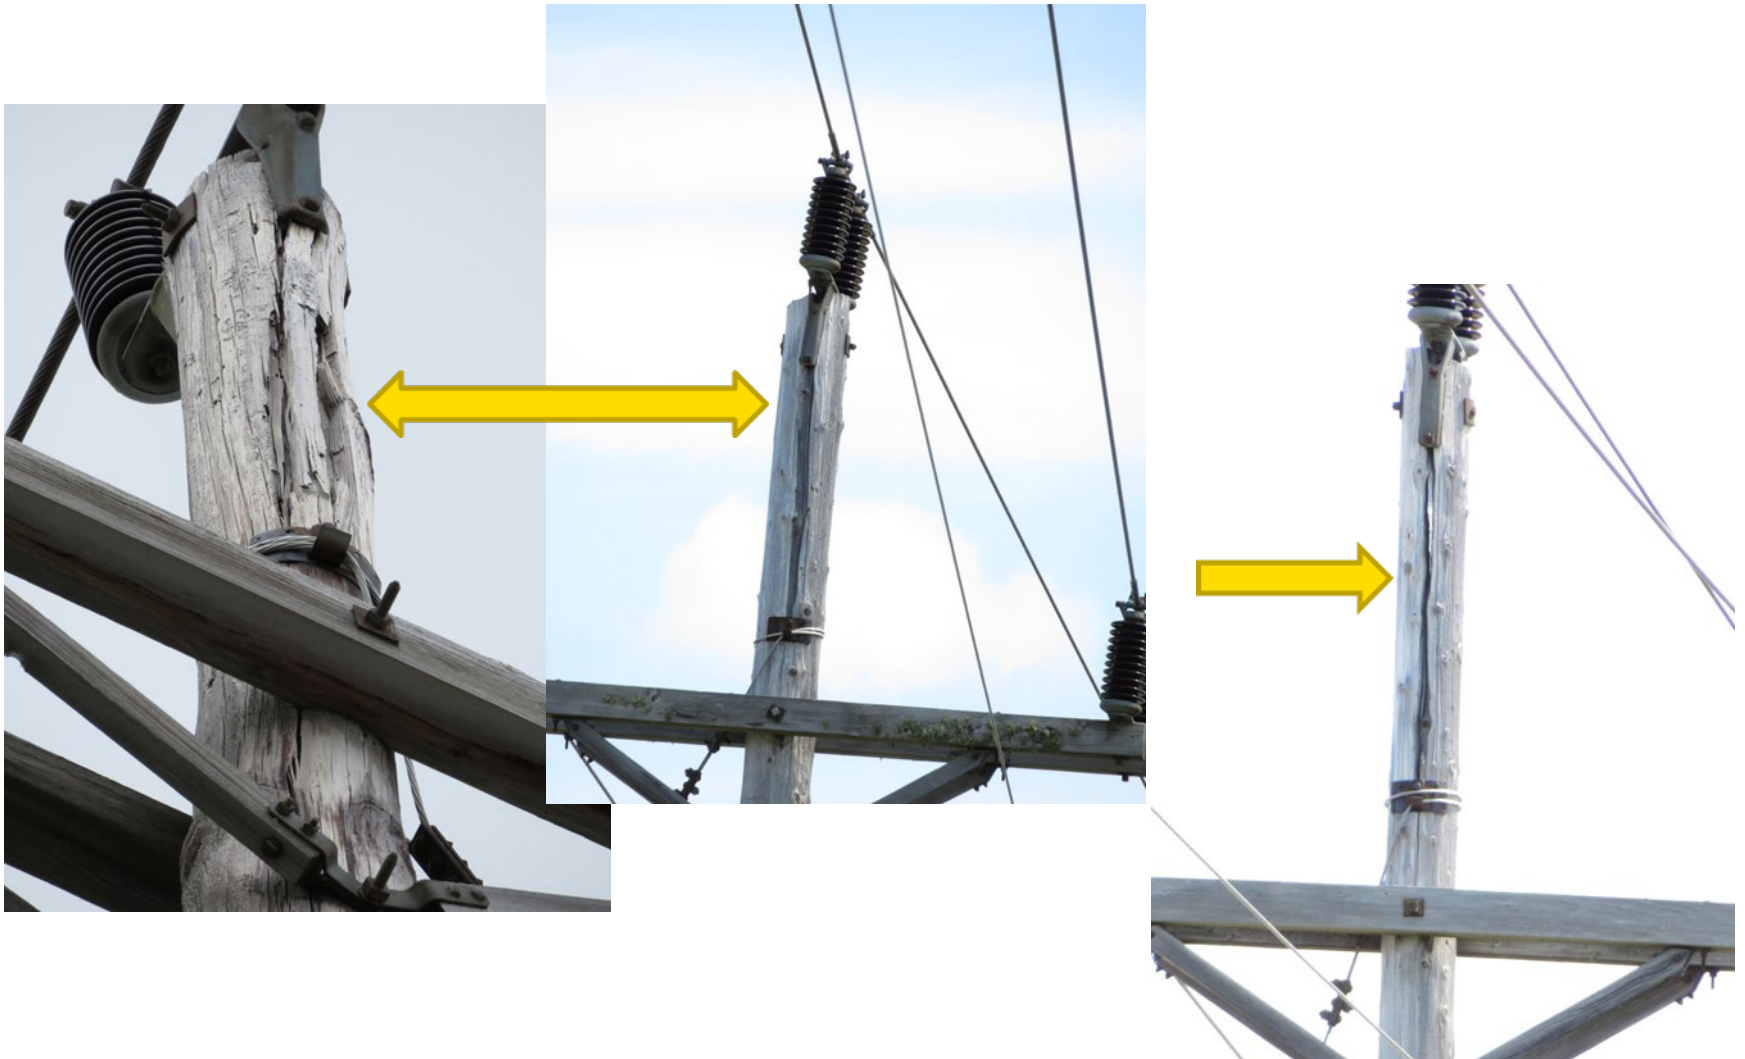
# Line 6903 Rebuild continued...

**Brown glass post type insulators, cracked crossarms and rejected pole due to internal decay**
